# Individual Adaptation and Conversion Report

BEN509: Conversion and Adaptation

Kyle Nugent – B00737253 - Friday 7<sup>th</sup> May 2021

Knappa Vale, 36 Knappagh Road,  
Knockaneagh, Co. Armagh

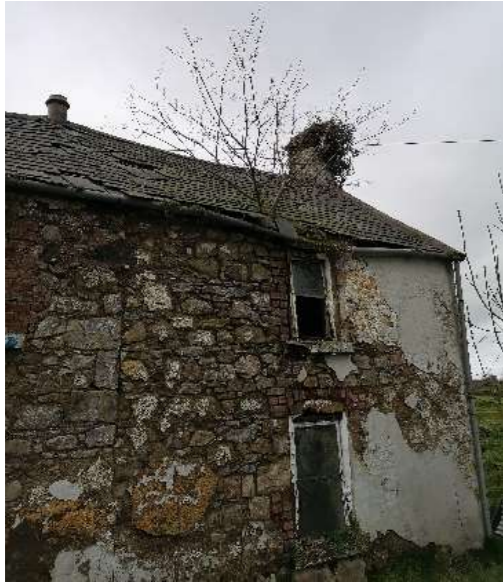
Fig16: Wall Render (Author, 2021)

Large amount of lime render has fallen off the south facing wall due to heavy moisture penetration and lack of care.

Seen within the condition survey, the walls are currently in a poor condition. There is large areas where the external lime render has fallen off the exterior. This is thought to be the effects of neglect and moisture damage. Crumbling of the red brick is noticeable from ground level, most likely caused by frost damage. These bricks will be expected, and repairs made through a patching technique using locally sourced reclaimed bricks (BRE, 1998). After the brickwork/stonework is properly cared to, a lime render will have to be reapplied. Before the first and second layer of render is applied, it is important that any loose render is removed.

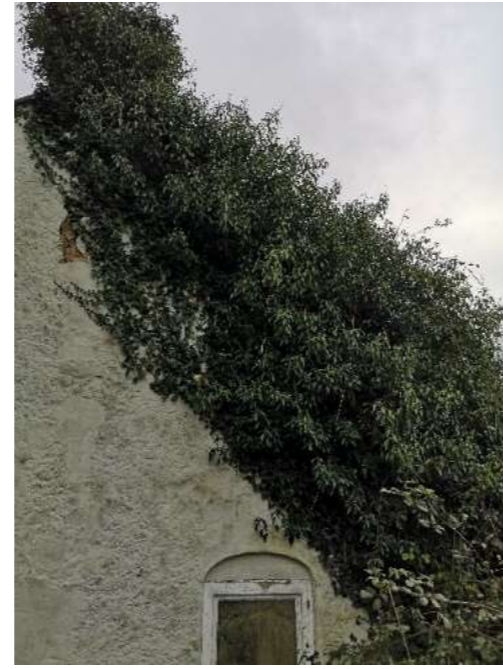
Fig17: Vegetation (Author, 2021)

High amounts of vegetation ingress is present across the building; possible damage caused.

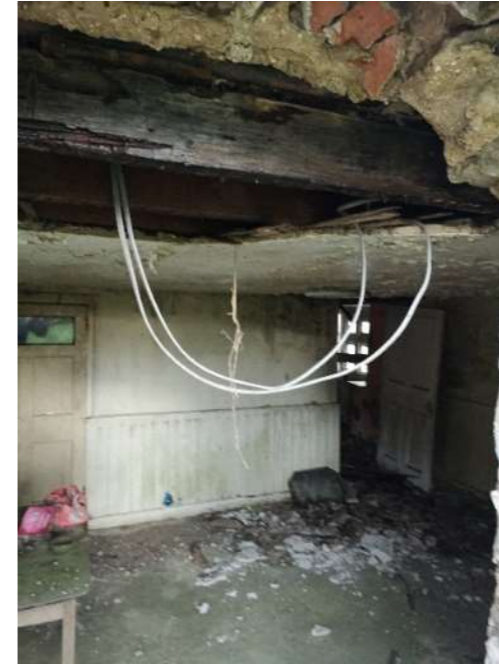
Fig18: Floor Joists (Author, 2021)

Exposed floor joists has brown rot. The strength and stability of the members may be compromised.

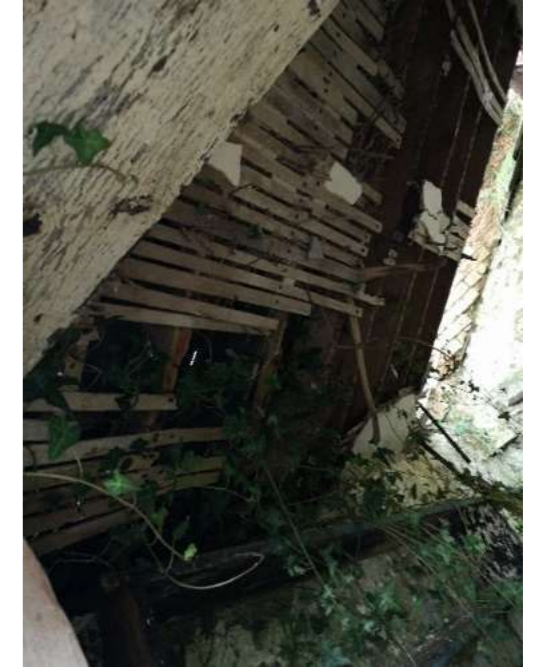
Fig19: Ceilings (Author, 2021)

In parts the ceiling has collapsed due to rain ingress. Exposed timber lathing is noticeably damaged.

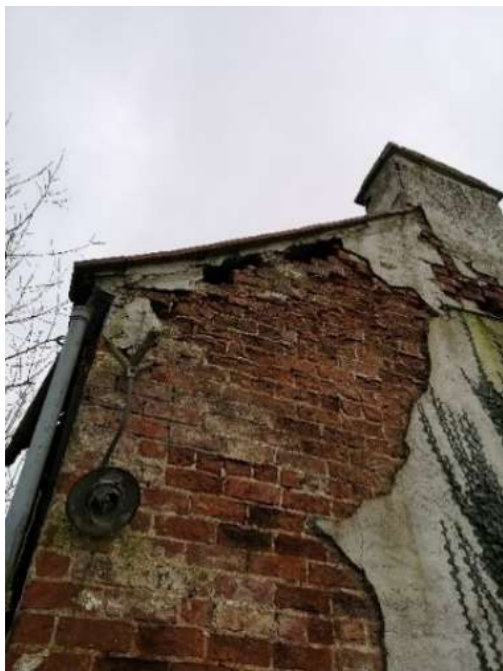
Fig20: External Brick (Author, 2021)

Crumbled brick is present on the north facing wall, caused by frost damage. Large area of lime render has fallen off.

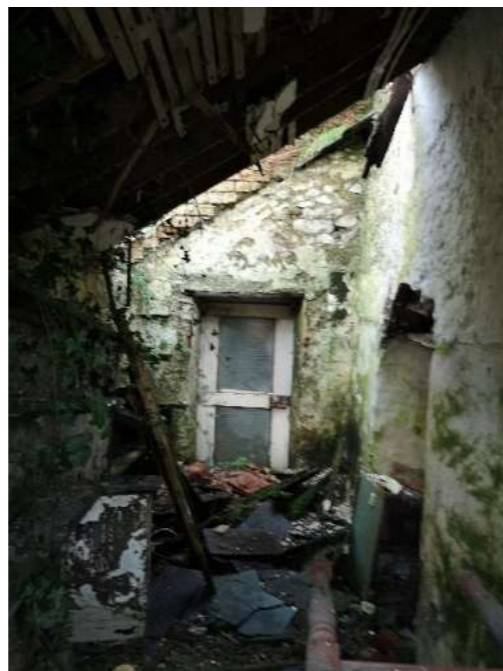
Fig21: Mould (Author, 2021)

Heavy amount of mould is present on internal stone walls. Discoloration and crumbled plaster is also seen within this area.

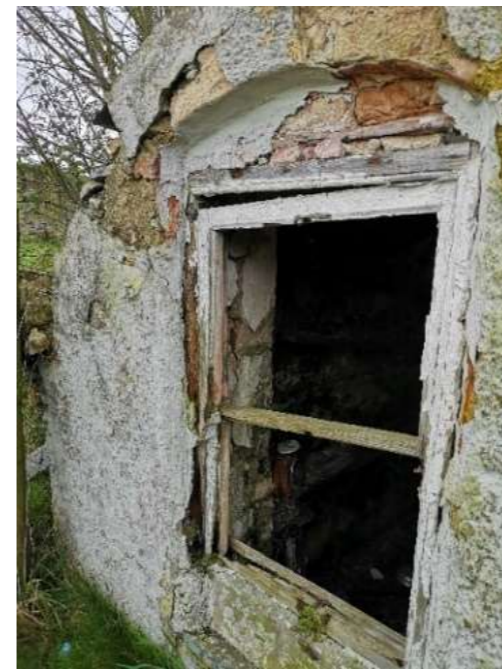
Fig22: Windows (Author, 2021)

Sash windows majorly damaged across the object. Affected frames are the only surviving element in various cases.

The wooden sliding sash windows of the building are heavily damaged, and therefore unlikely to be recovered. Replacement windows should not affect the character of the building. Due to the new use of the building, it is highly favorable that the replacement windows are double glazed. For this to happen, it needs to be granted within listed building consent and agreed with the department of Communities. Replacement windows must replicate materials, finishes, sash boxes and glazing bars (Department of Communities, 2021). Due to these requirements, all window replacements will be bespoke.

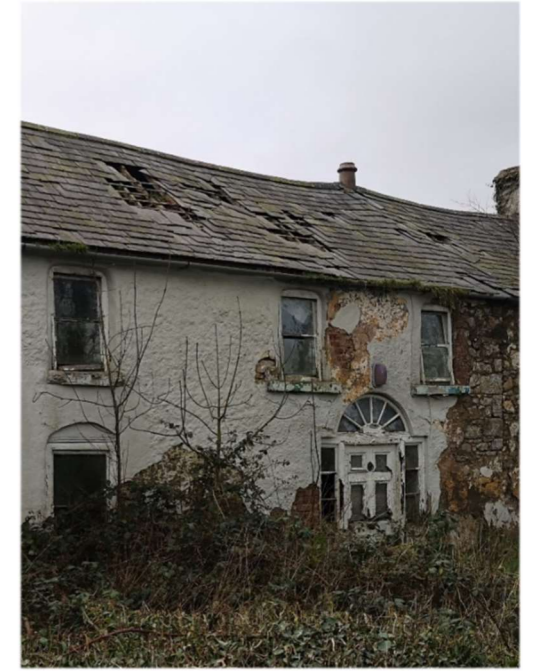
Fig23: Roof (Author, 2021)

The damaged roof is the main cause of moisture damage. Considerably amount of roof tiles missing on south side.

There is a large amount of missing roof tiles at the front side. This has allowed water to enter the building, damaging the roof trusses and ceilings. Roof tiles, which have not been damaged, will not be replaced. However, all roof tiles will be removed, during works, for treatment. Etex Rivendale Black Slates, which comply with strength requirements stated within BS EN 492 (BSI, 2018), will be used as replacement tiles (JJ Roofing Supplies, 2021). They match aesthetically and will be placed in a discreet positions (BRE, 1998).

Timber trusses which are heavily damaged will need to be replaced. Haldane Fisher raised tie trusses, built in accordance to BS EN 1995-1 (BSI, 2014), has been specified. New timber can provide assistance to any existing truss deemed usable, through a check bolting system (Department for Communities, 2021).
