# Individual Adaptation and Conversion Report

BEN509: Conversion and Adaptation

Kyle Nugent – B00737253 - Friday 7<sup>th</sup> May 2021

Knappa Vale, 36 Knappagh Road,  
Knockaneagh, Co. Armagh

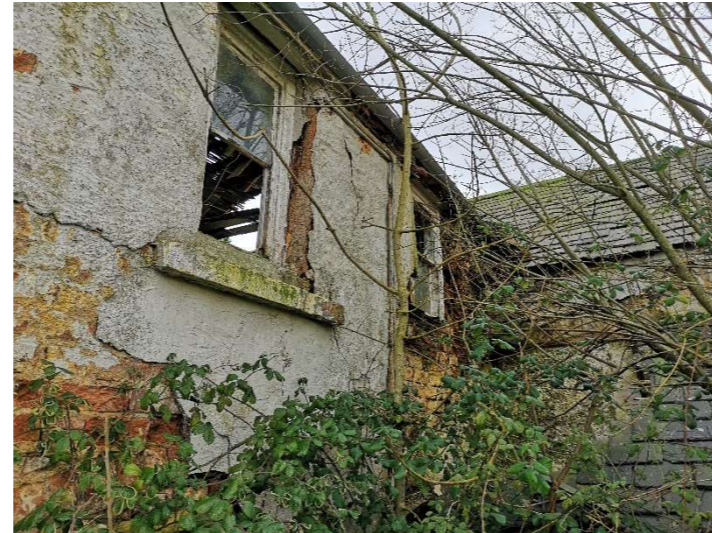
Fig2: Building Condition (Author, 2021)

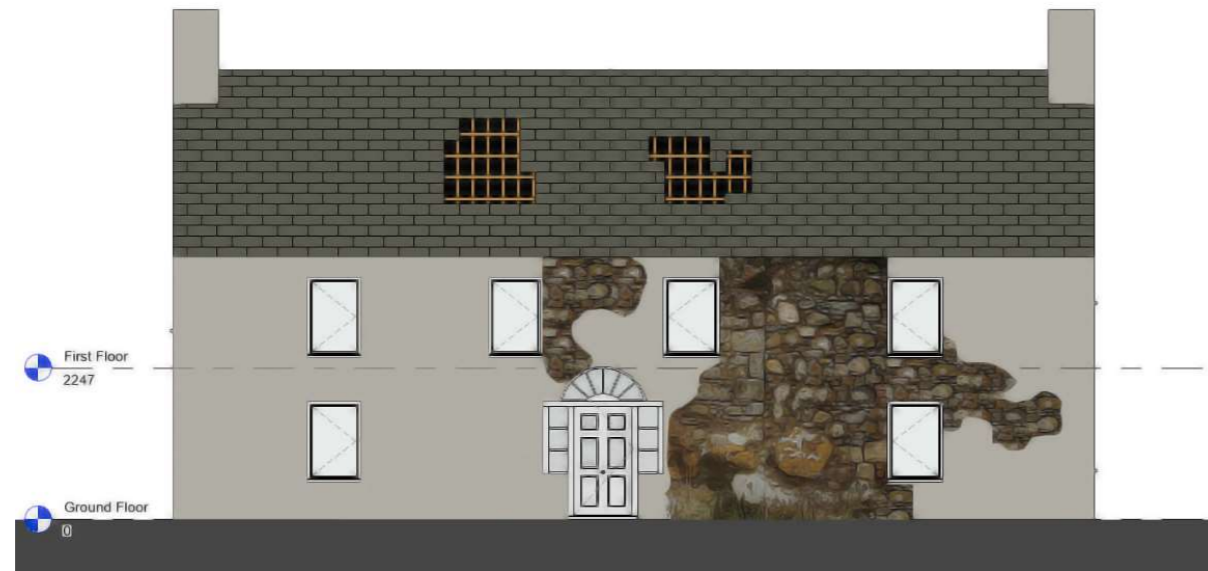
Fig12: Condition South Elevation (Author, 2021)

Large amount of lime render has fallen off the south facing wall due to heavy moisture penetration and lack of care.

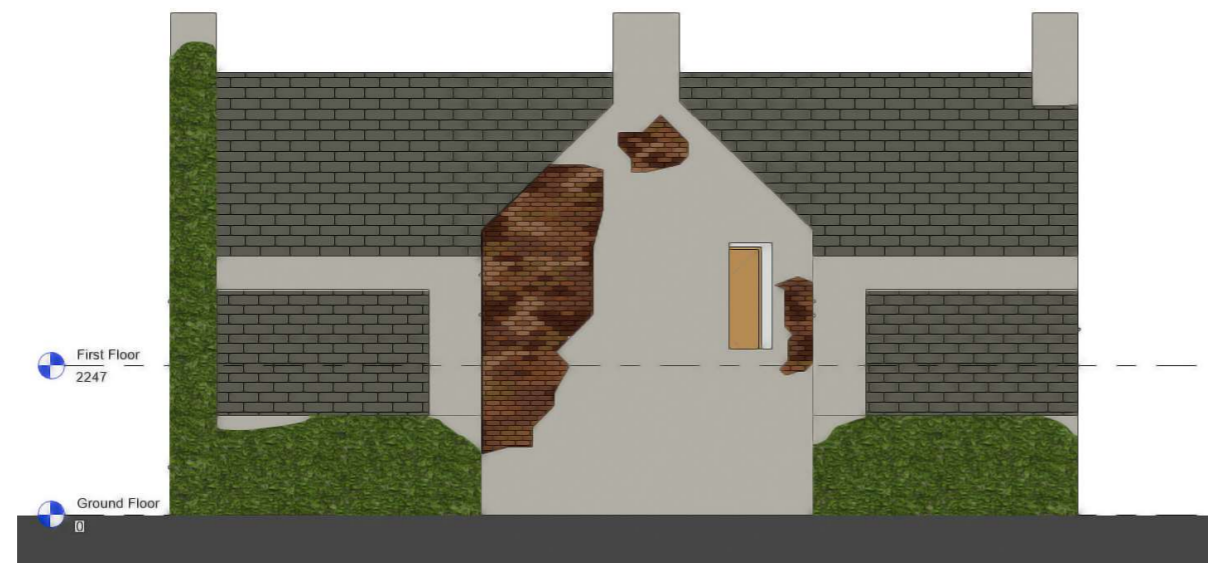
Fig14: Condition North Elevation (Author, 2021)

Crumbled brick is present on the north facing wall, caused by frost damage. Large area of lime render has fallen off.

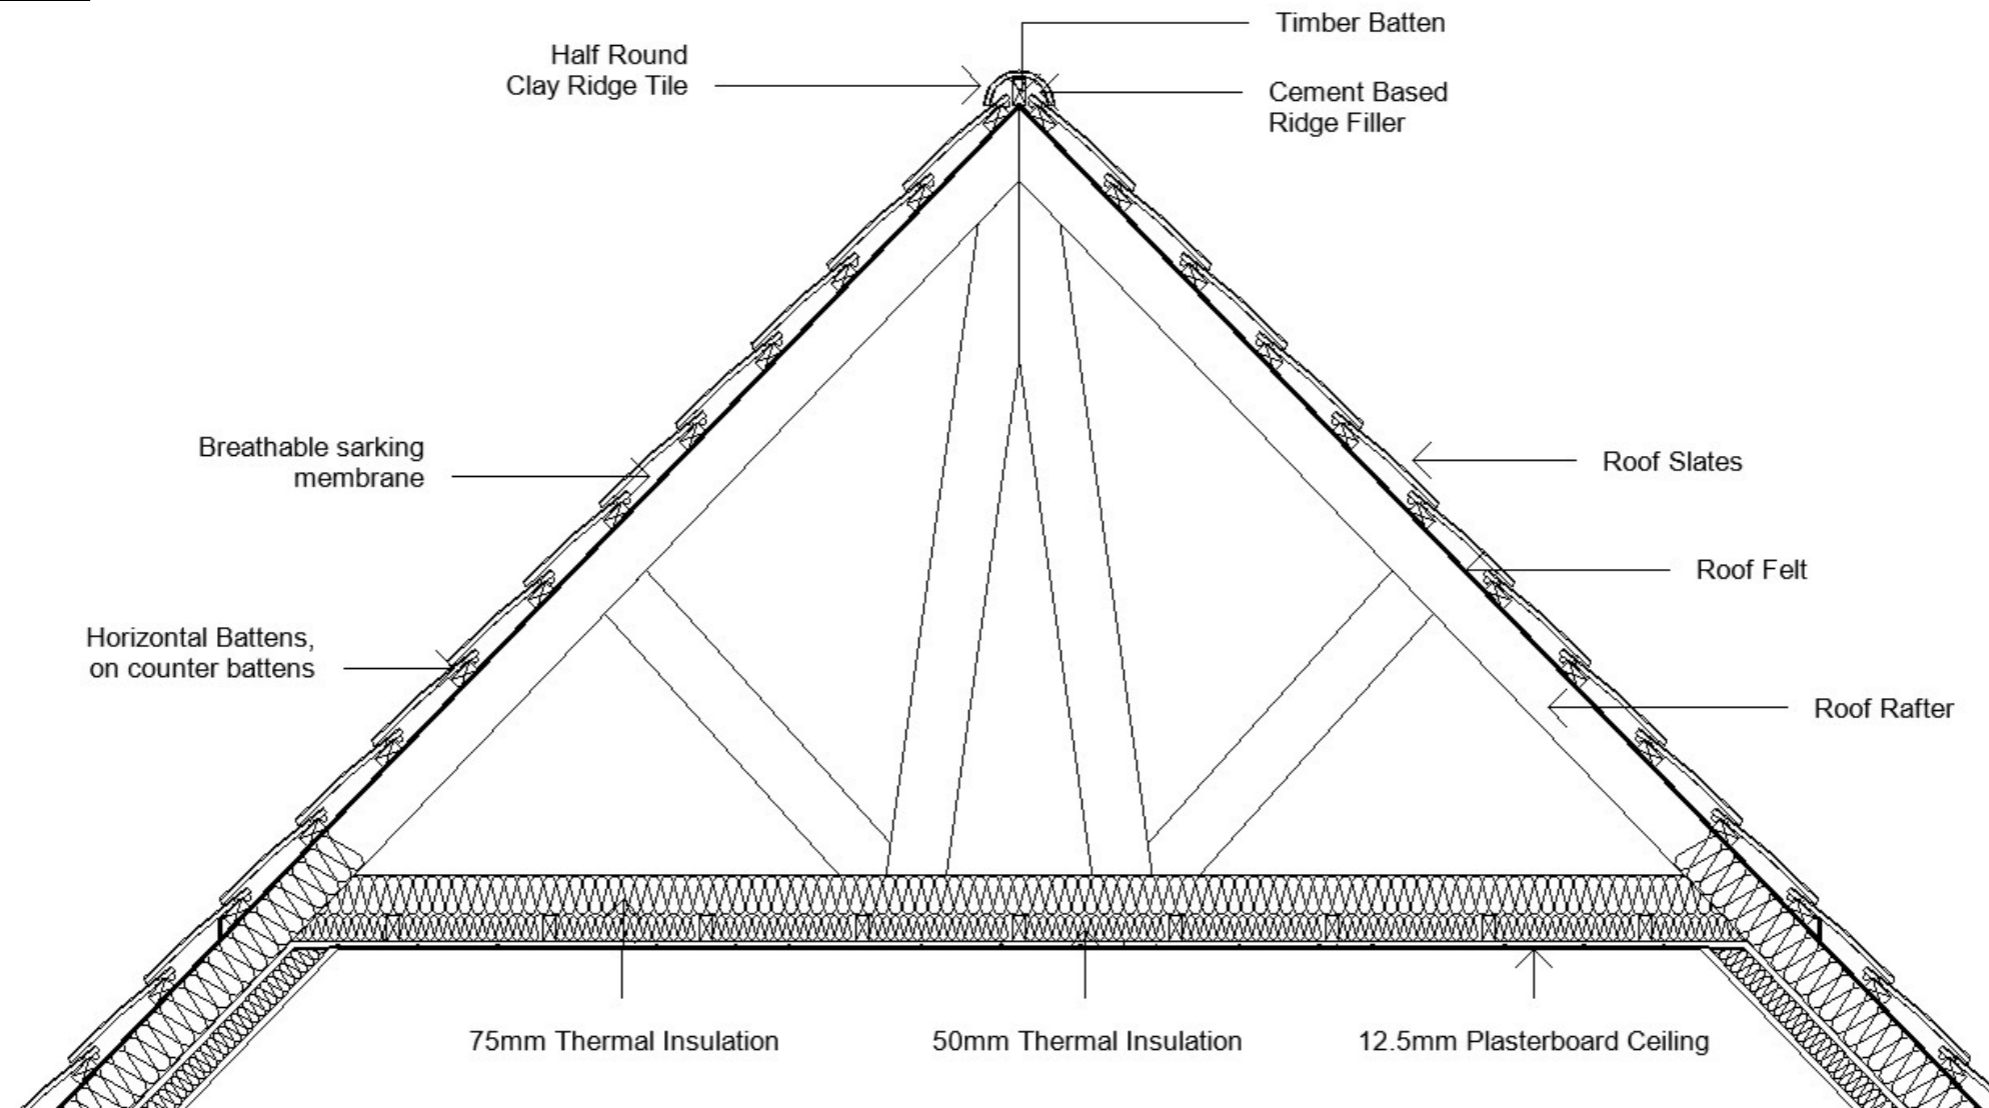
Fig64: Roof Detail (Author, 2021)

There is a large amount of missing roof tiles at the front side. This has allowed water to enter the building, damaging the roof trusses and ceilings. Roof tiles, which have not been damaged, will not be replaced. However, all roof tiles will be removed, during works, for treatment. Etex Rivendale Black Slates, which comply with strength requirements stated within BS EN 492 (BSI, 2018), will be used as replacement tiles (JJ Roofing Supplies, 2021). They match aesthetically and will be placed in a discreet positions (BRE, 1998).

Timber trusses which are heavily damaged will need to be replaced. Haldane Fisher raised tie trusses, built in accordance to BS EN 1995-1 (BSI, 2014), has been specified. New timber can provide assistance to any existing truss deemed usable, through a check bolting system (Department for Communities, 2021).

To improve the energy performance of the building, insulation will be fitted in between rafters, and internally. A semi-rigid insulation roll is to be used to prevent any area within these tight spaces being left uninsulated (Morgan, 2018). 100mm Rockwool RWA45 Semi-Rigid Insulation, which is certified to EN 131162 and is rated Euroclass A1 non-combustible, has been specified (Rockwool, 2021). This insulation will also be used within the ceiling and floors. Natural Rockwell insulation board has been specified for the inner face of the ceiling. This extra insulation will help reduce heat loss within the building.

British Gypsum’s 12.5mm Gyproc WallBoard has been specified for the ceiling and wall plasterboard. This plasterboard will provide 30 minutes fire resistance to BS 476: Part 22 (BSI, 1987) (British Gypsum, 2021).

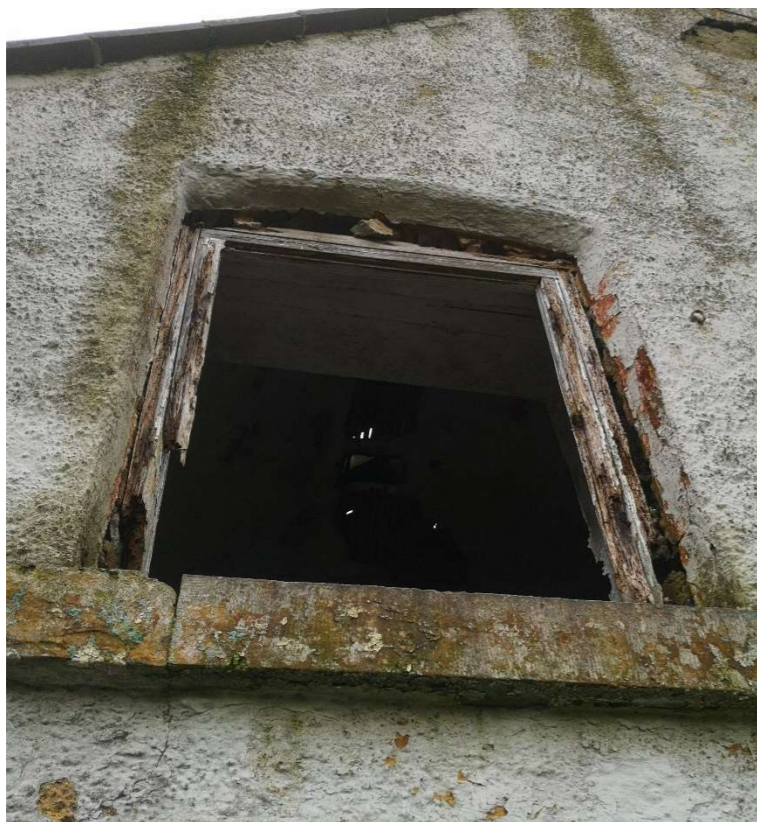
Fig67: Window Condition (Author, 2021)

50mm Xtratherm PIR Rigid insulation board will be mechanically fixed to the wall. No gaps should remain within this insulation layer, joins will be covered using a tape specified by the supplier. This insulation layer product BBA certification number is 08/4613 and is certified to BS EN ISO 9001 (BSI, 2015) and BS EN ISO 14001 (BSI, 2015) (Xtratherm, 2021). Insulation will also be added around window reveals. All window repairs/replacements will be undertaken before internal insulation works begin.

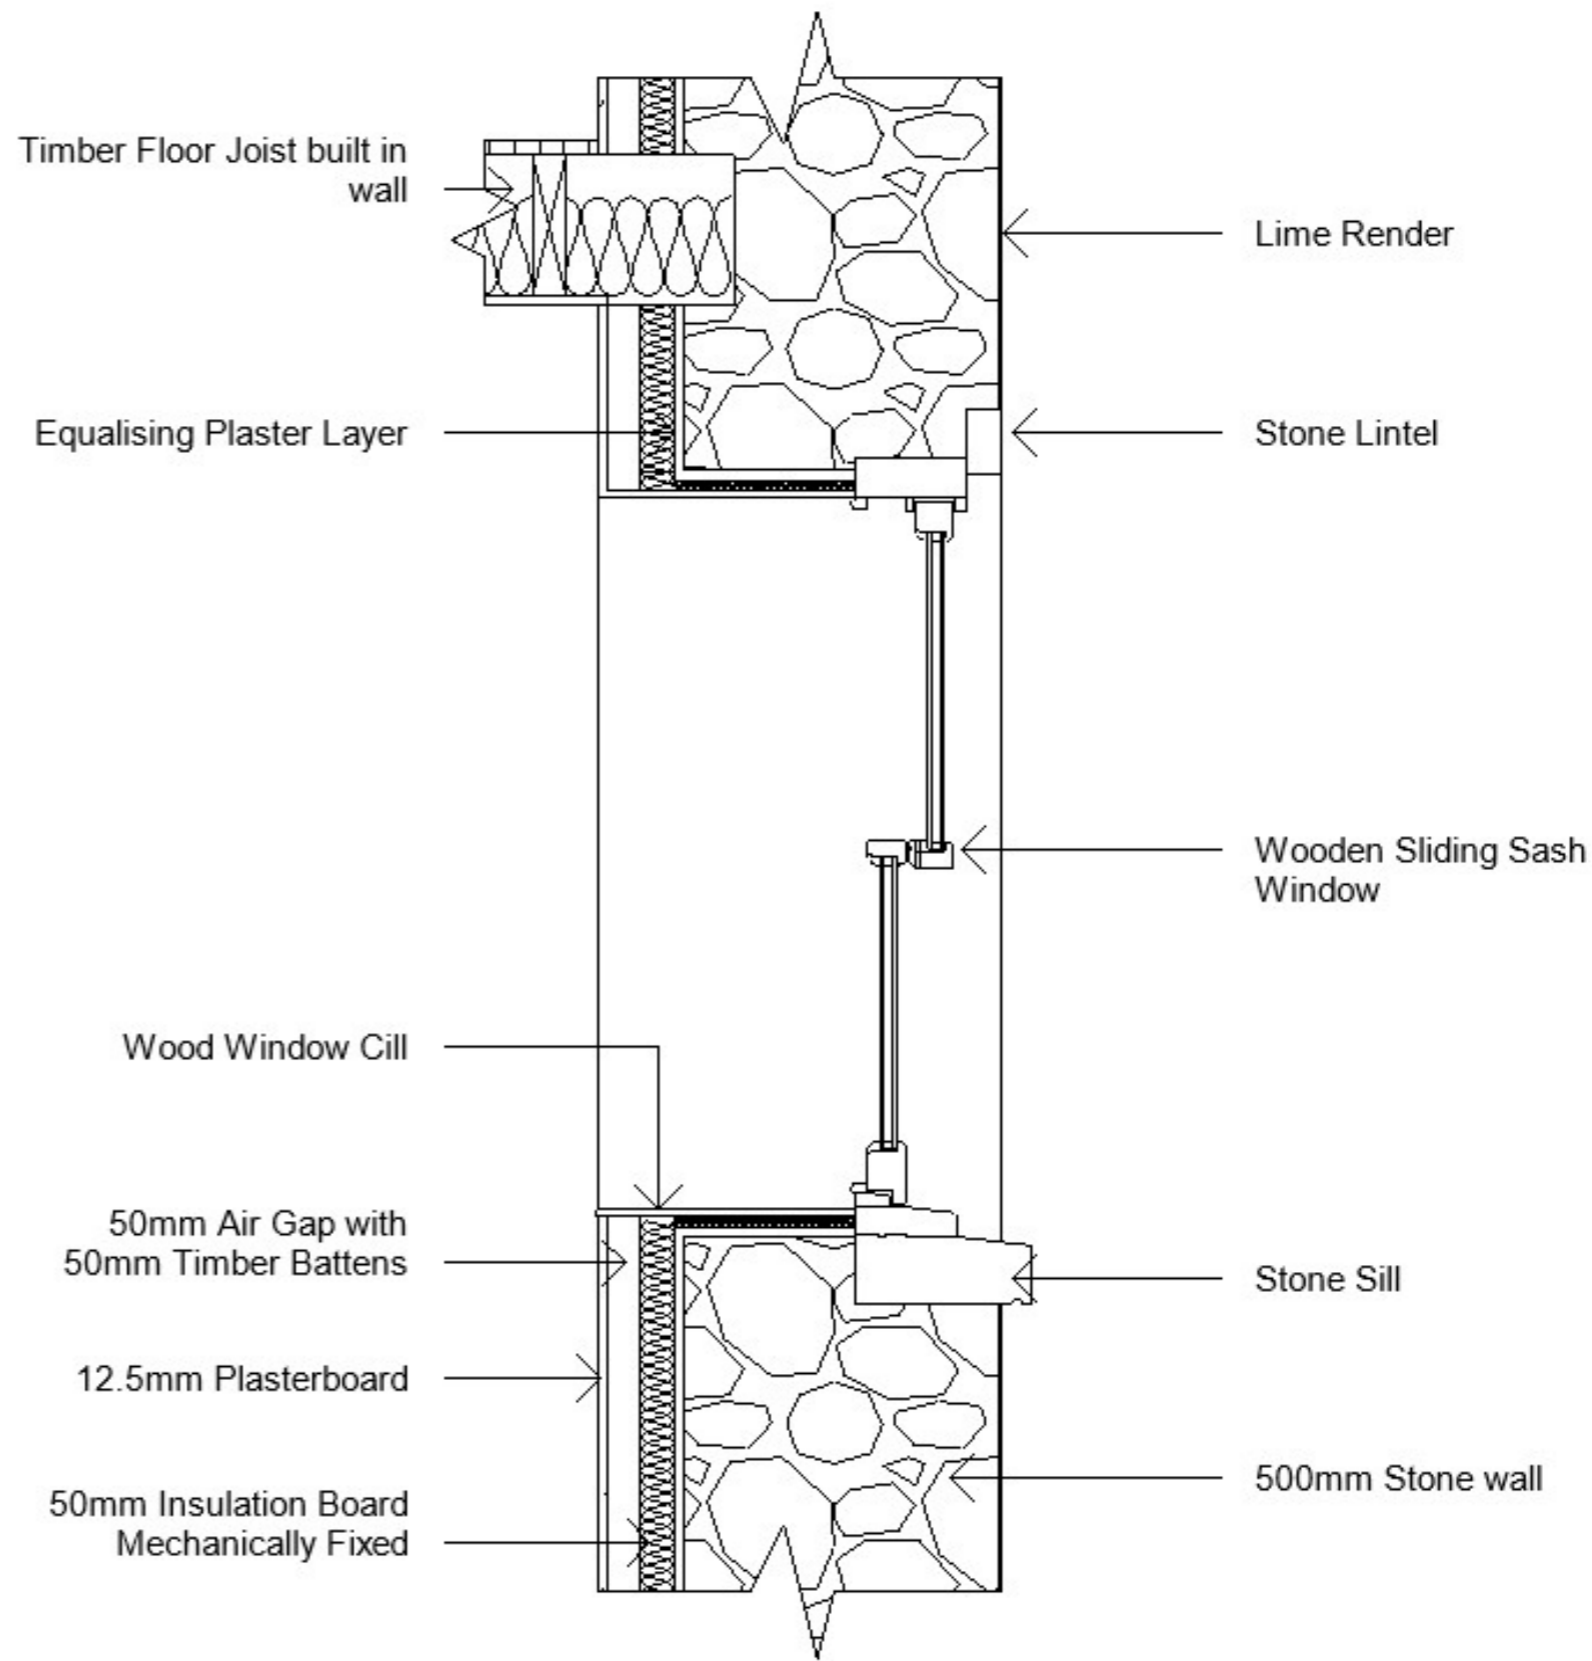
Fig68: Wall Detail (Author, 2021)

The current wall makeup will not provide adequate levels of energy efficiency for the new building use. A new insulation layer will be placed against the internal side of the stone wall, with timber battens creating an air cavity between that insulation layer and a plasterboard finish.

The interior side of the stone wall will need covered with an equalising plaster layer. Without this layer the walls would not be level, which would create difficulties when fixing insulation boards. It will also aid in extracting moisture from within the wall (Morgan, 2018).

The wall plasterboard will be British Gypsum’s 12.5mm Gyproc WallBoard, similar to plasterboard ceilings. They shall be fixed to 50mmx50mm timber battens at 600mm centres. Within the air gap, services can be installed. This feature makes this method popular when services and fittings are also being replaced (BRE, 1999).
